SITE RADIOLOGICAL CHARACTERIZATION REPORT

November 2013
Clean Harbors (Reid Supply) Facility
Wichita, KS

USA Environment LP
10234 Lucore St
Houston, TX 77017

Project ID # 2950-NR-H026

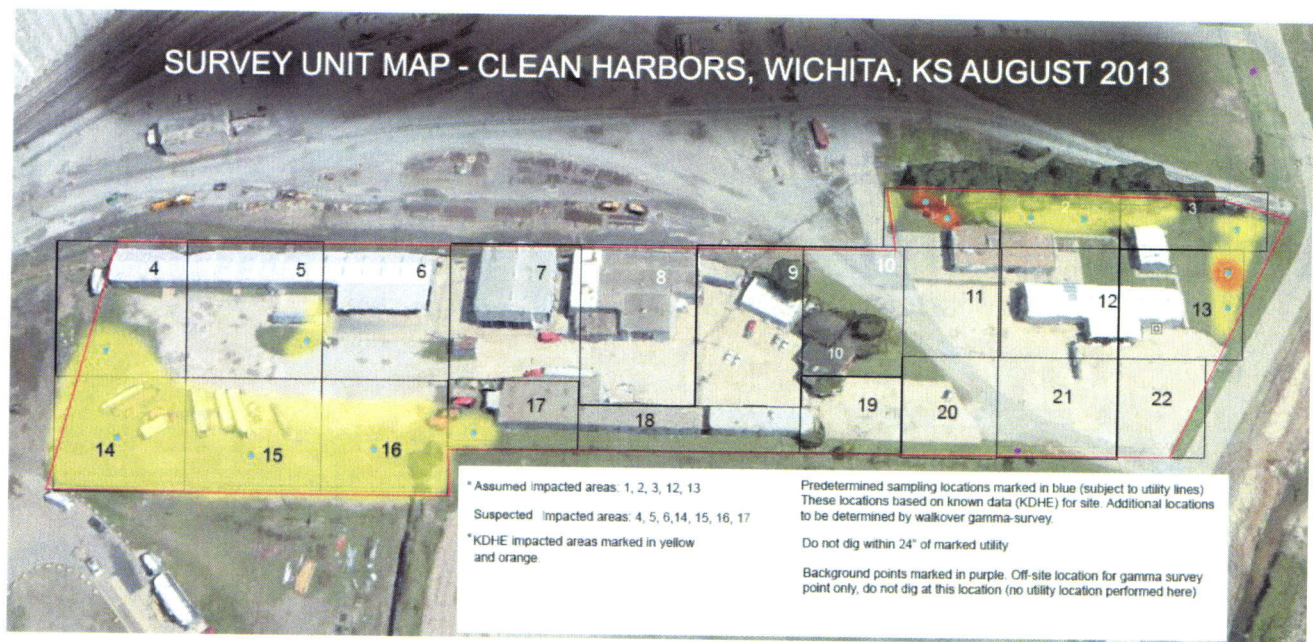
Figure 1. Clean harbors Facility divided into 22 survey units with the KDHE assumed contaminated zones highlighted.

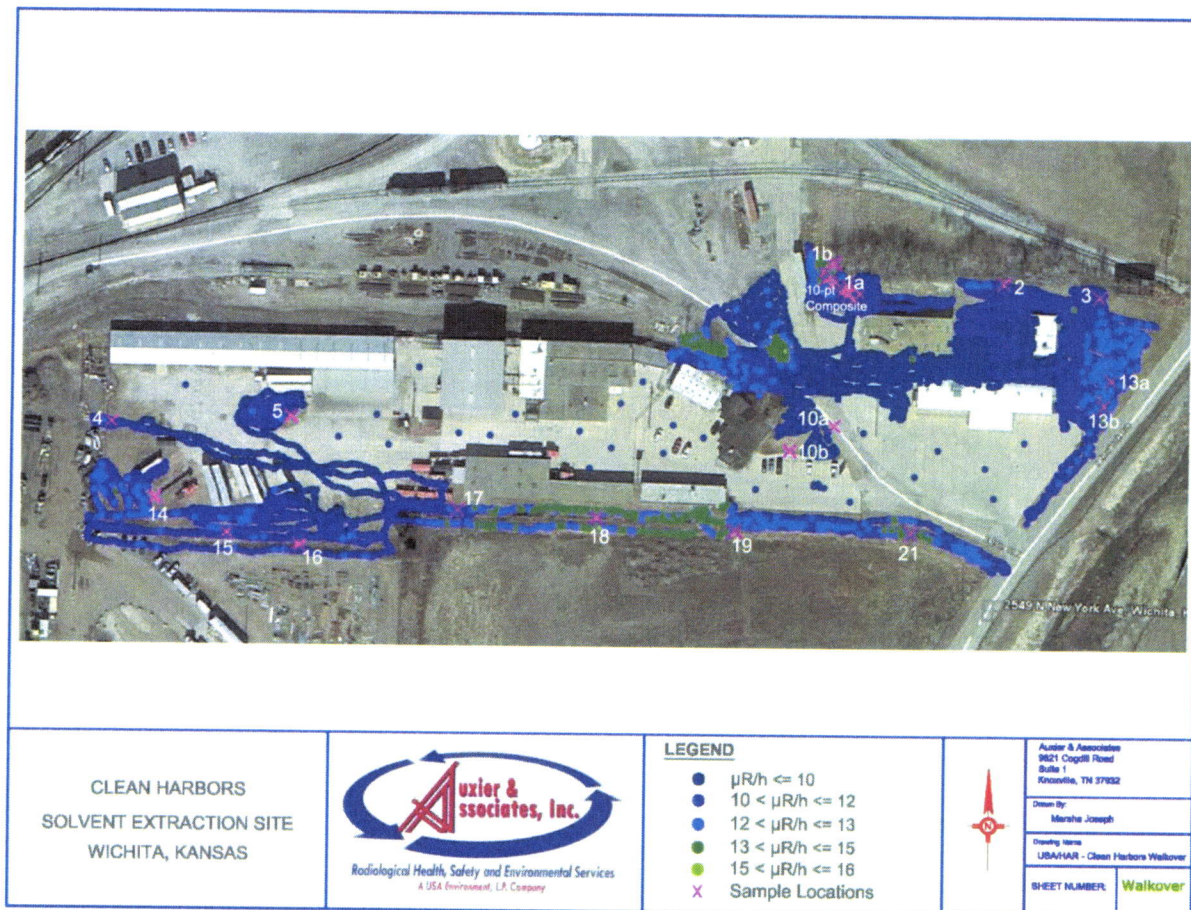
Figure 4 displays the survey results and sampling locations from the first two mobilizations overlaid onto satellite imagery of the facility. (A larger version of this map is contained in Appendix I) Gamma survey results were unremarkable in that the action level of 20 $\mu\text{R/hr}$ was never recorded in any area surveyed. The maximum gamma radiation levels were found to be 16 $\mu\text{R/hr}$.

Figure 4. Survey results and sampling locations from first two mobilizations.

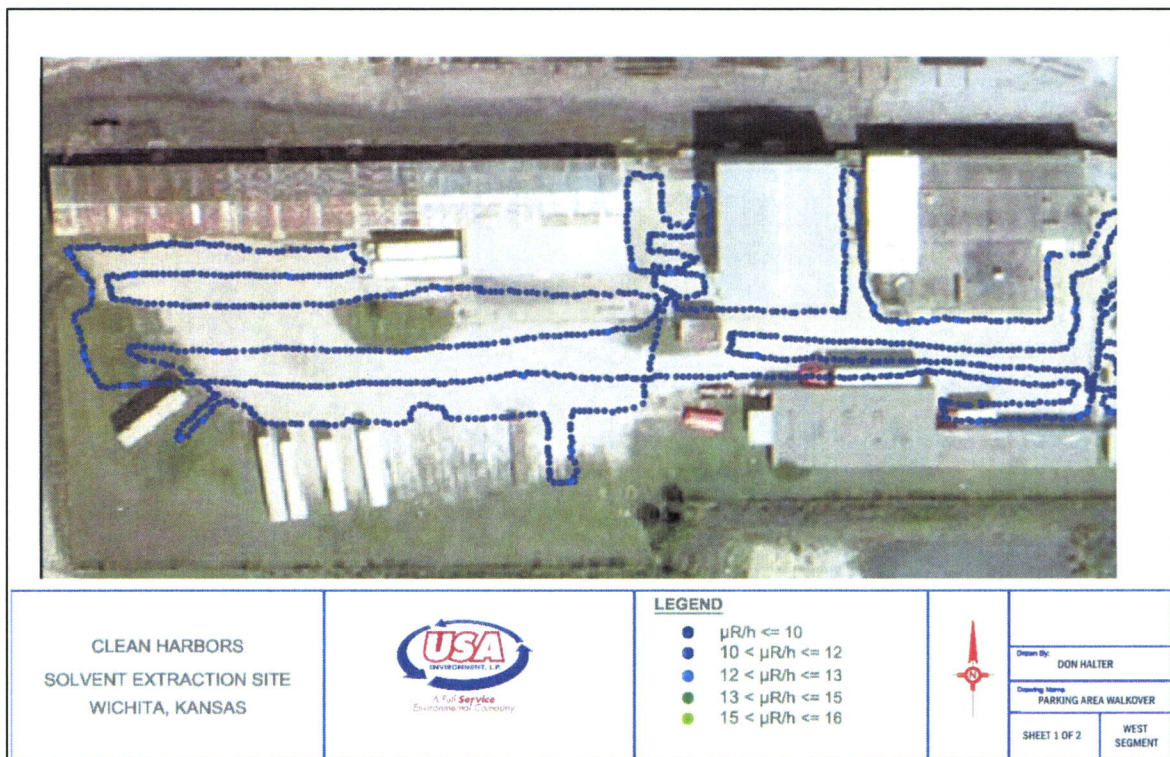
Figure 5a. Gamma-walkover survey for paved outdoor areas (West half).

No measurements exceeded the 20 mR/hr action level. Only a few areas, already noted in previous surveys, were found to have measurements above background. The majority of these areas were adjacent to the red-clay brick walls of the administrative buildings. After reviewing the gamma-walkover data, it was suspected that the red-clay bricks contained low levels of NORM and were contributing to the gamma exposure rates detected adjacent to the buildings rather than any non-natural source present in the soil in these areas. The additional walkover results are displayed in Figures 5a and 5b above. Larger versions of these survey maps are included in the appendices.

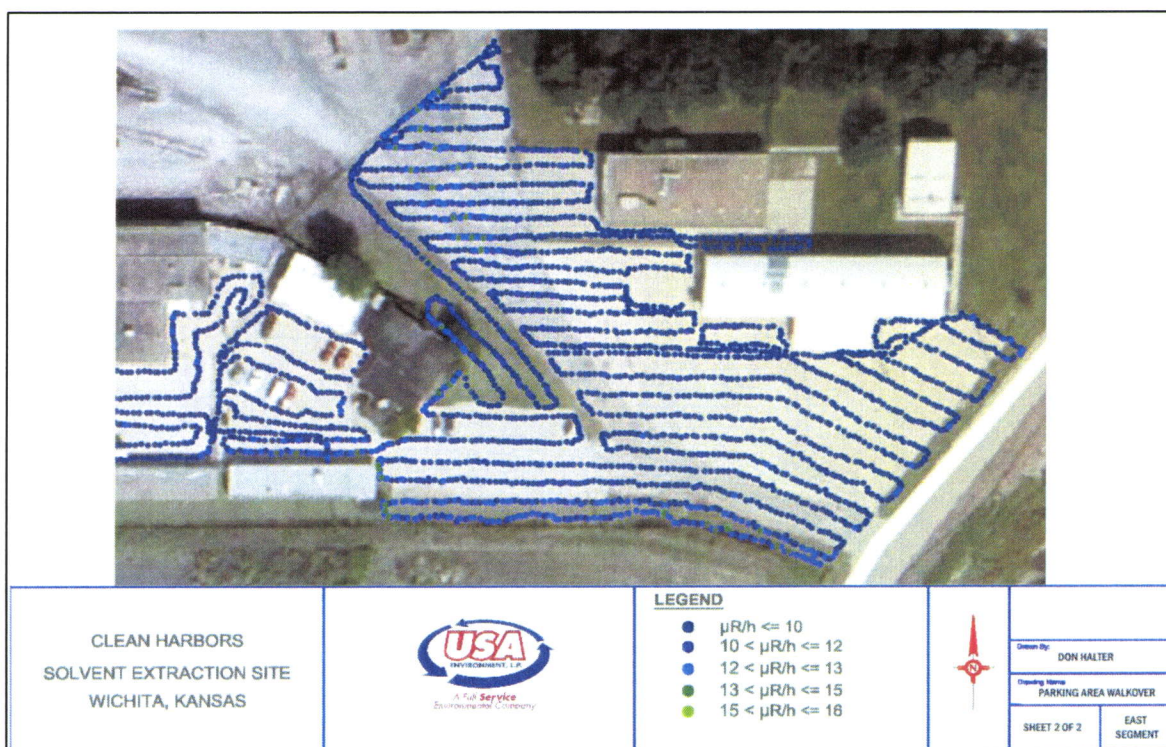
Figure 5b. Gamma-walkover survey for paved outdoor areas (East half).

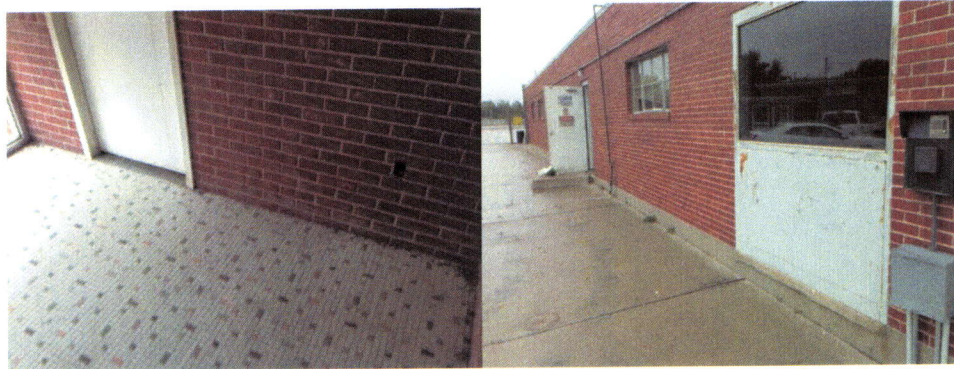
Limited direct alpha/beta counting and sampling was conducted in these buildings based on their historic and current use. These measurements and sampling were conducted in most probably locations such door entryways, lobbies and other high-use areas. The foyer and bathroom area of Building A were included to ensure the elevated gamma readings were actually due to material within the construction materials and not external contamination. No removable contamination or fixed alpha contamination was detected. Direct beta counting was only slightly elevated and attributed to the natural emission from NORM contained in the surface of the bricks and glaze.

Figure 7. Red clay brick and ceramic tile in the foyer and on the veneer of Building A.

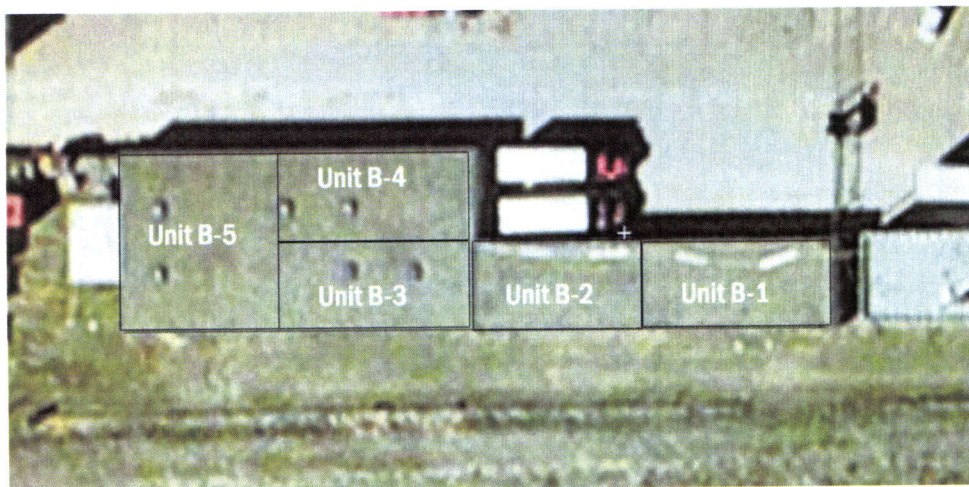
Figure 8. Building B and its survey units.

Units 1 and 2 were individual rooms, with units 3, 4 and 5 being divisions within the third large room. Each unit was divided into sub-units using an 8' x 8' grid pattern. This resulted in ~ 25-30 direct alpha/beta scanning locations and wipes and ~120 for the entire building. Gamma exposure rates averaged 10 uR/hr for the entire building with no elevated readings found. Likewise, no elevated removable or total alpha/beta contamination was found.

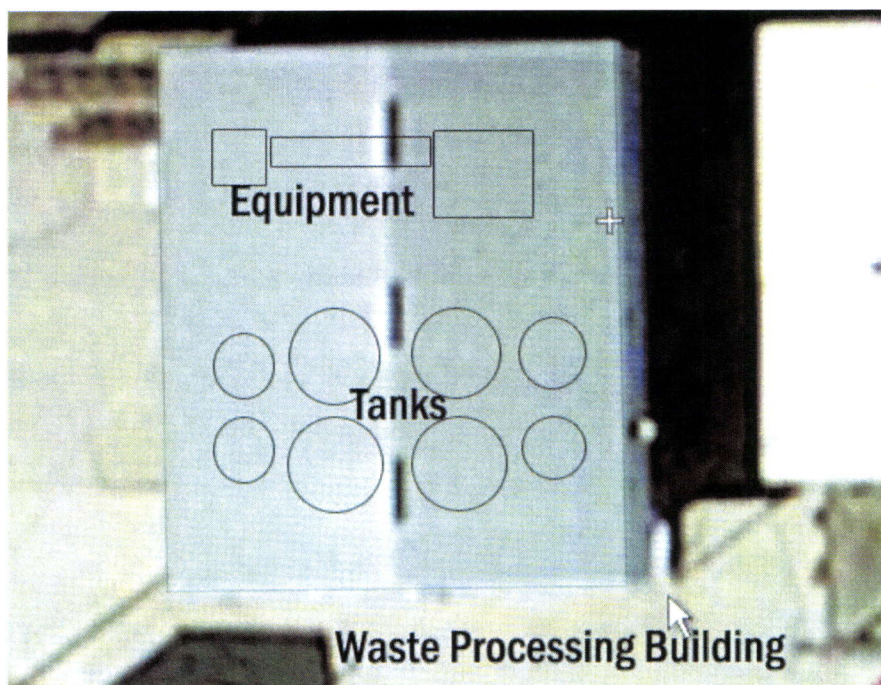
Building C consists of a metal roof and raised, bermed ground floor. This structure houses the large hazardous waste treatment/processing tanks and only has one enclosed wall on the North face. This entire structure was considered a single survey area. All surfaces except a portion of the rear (North) end that could not be accessed due to equipment and scrap metal received 100% coverage during the gamma walkover. In addition, the bases and interiors of tanks (when accessible) were also surveyed. All gamma exposure rate measurements were less than 9 $\mu\text{R/hr}$. This structure was divided into 23 sub-units. A total of 35 locations were chosen for direct alpha/beta measurements and wipe sampling and in some cases included the tanks themselves. No instances of contamination of any kind were detected.

Figure 9. Building C – Waste Processing Building

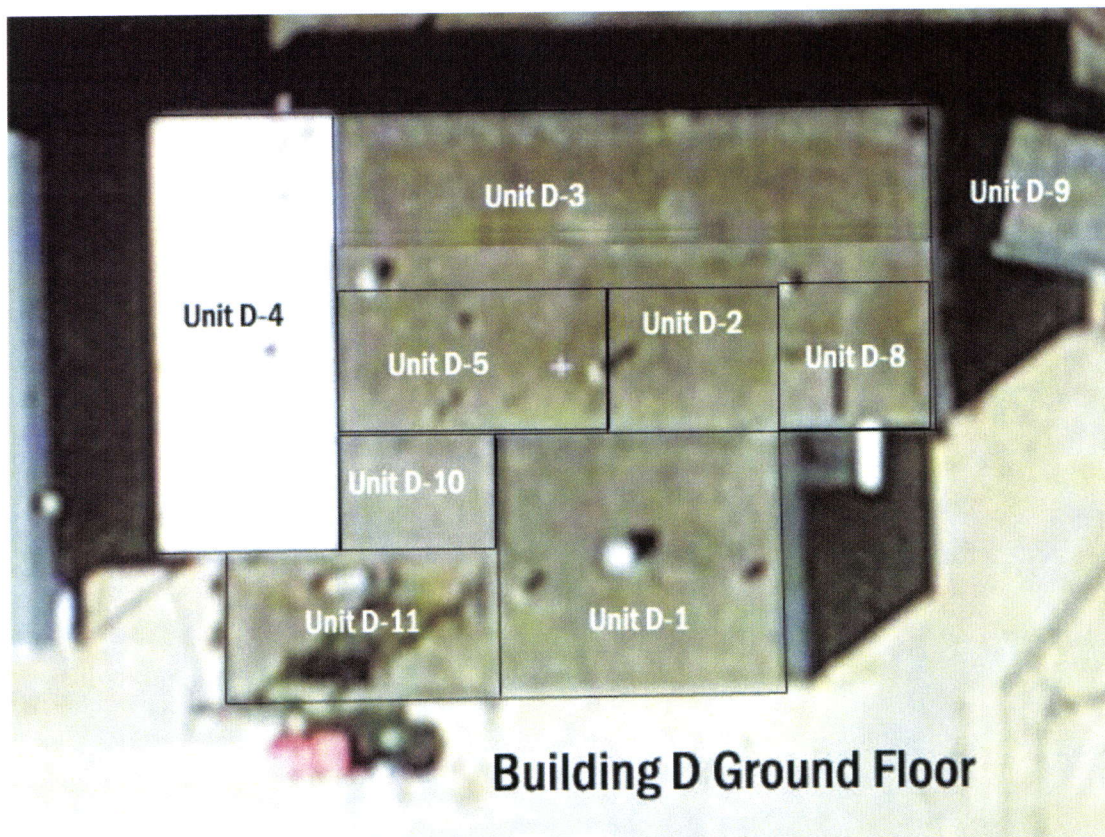
Unit 1 was a material receiving room and was a large open room $\sim 25' \times 40'$. This room was divided into sub-units $8' \times 8'$. During the 100% gamma survey, all interior areas were less than 12 $\mu\text{R/r}$ over flooring with the exception of the following: areas along the wall base on the South, North and East walls were 14-16 $\mu\text{R/hr}$ along the wall/floor interface; and the entire West wall and interface between wall and floor were 14-18 $\mu\text{R/hr}$. While not exceeding the action level of 20 $\mu\text{R/hr}$, these were distinguishable from background. It was initially suspected that trace amounts of contamination may be

present along the crevices between walls and floors. Direct alpha/beta counting as well as wipe sampling did not result in the detection of any contamination. Upon investigation, it was discovered that the exterior base of the building was constructed of the same red-clay brick used on the administration buildings. The decorative borders were resulting in slightly elevated gamma readings along the wall/floor interface on the interiors. Likewise, the entire West wall is constructed of this red brick and results in an average gamma exposure rate of 15-16 $\mu\text{R/hr}$ along its surface.

Figure 10. Building D ground floor survey unit layout.

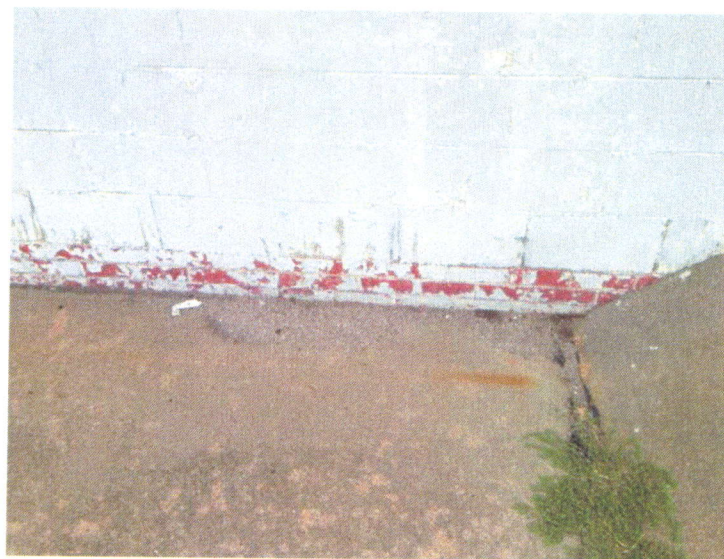
Unit 2 had similar findings. This area had numerous locations along walls with gamma measurements from 14-16 $\mu\text{R/hr}$. Because of this, the unit was divided into smaller 5'x5' sub-units to ensure adequate coverage of the surfaces for alpha/beta detection. No alpha or beta radiation above background was detected in any of the locations for direct or removable contamination. It was also noted that all areas associated with slightly elevated gamma exposure rates also contained painted-over decorative borders constructed from the red brick.

Figure 11. Decorative red-brick base around building D.

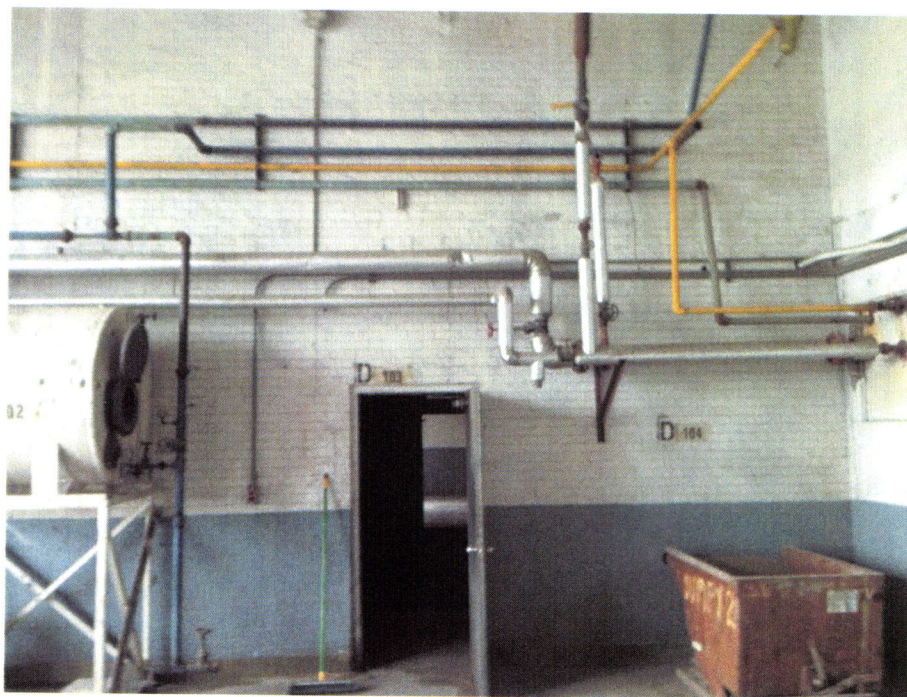
Figure 12. West wall of survey Unit D1 showing the entire wall being comprised of painted red-clay brick.

All elevated gamma exposure rates detected within the Building D complex were associated with the red-clay brick being used as decorative trims. Even with the red brick, no areas were found to exceed the action level of 20 $\mu\text{R/hr}$. The lack of any detectable alpha/beta contamination via direct counting and wipe sampling supported the assumption that all elevated gamma measurements were due to NORM sources in the building construction materials. This building was determined to be non-contaminated.

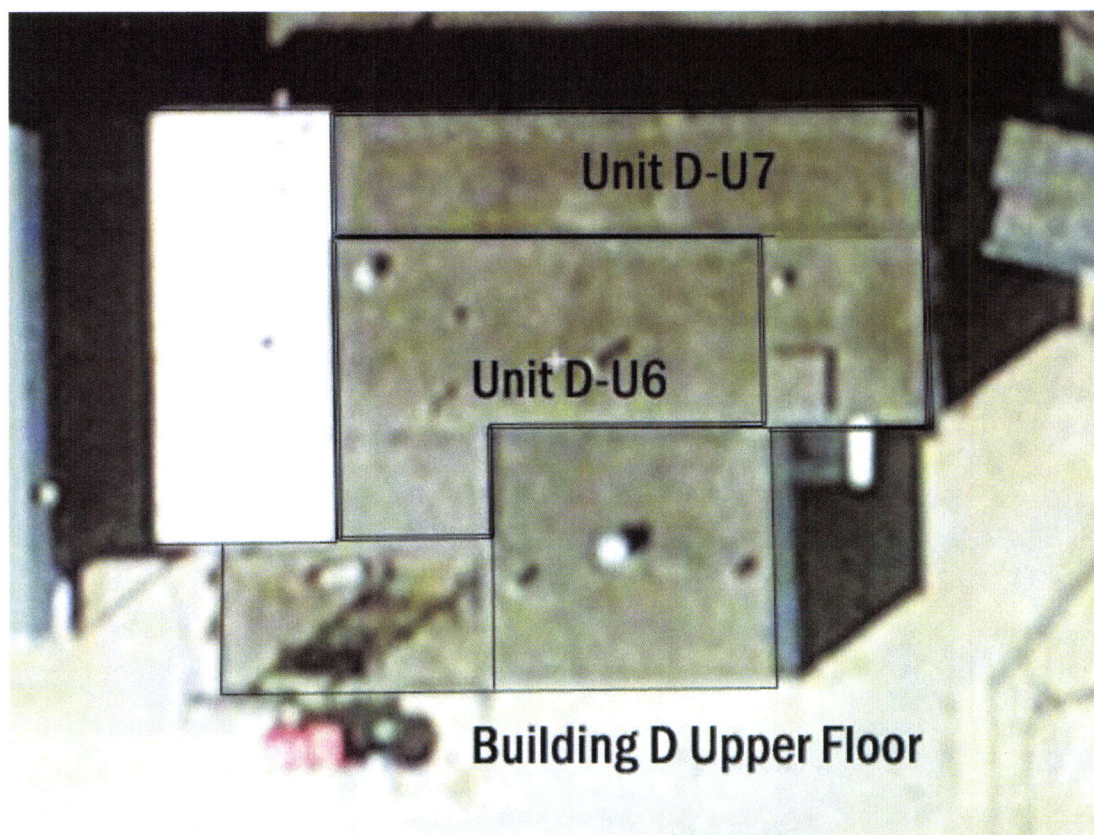
Figure 13. Building D upper floor survey unit layout.

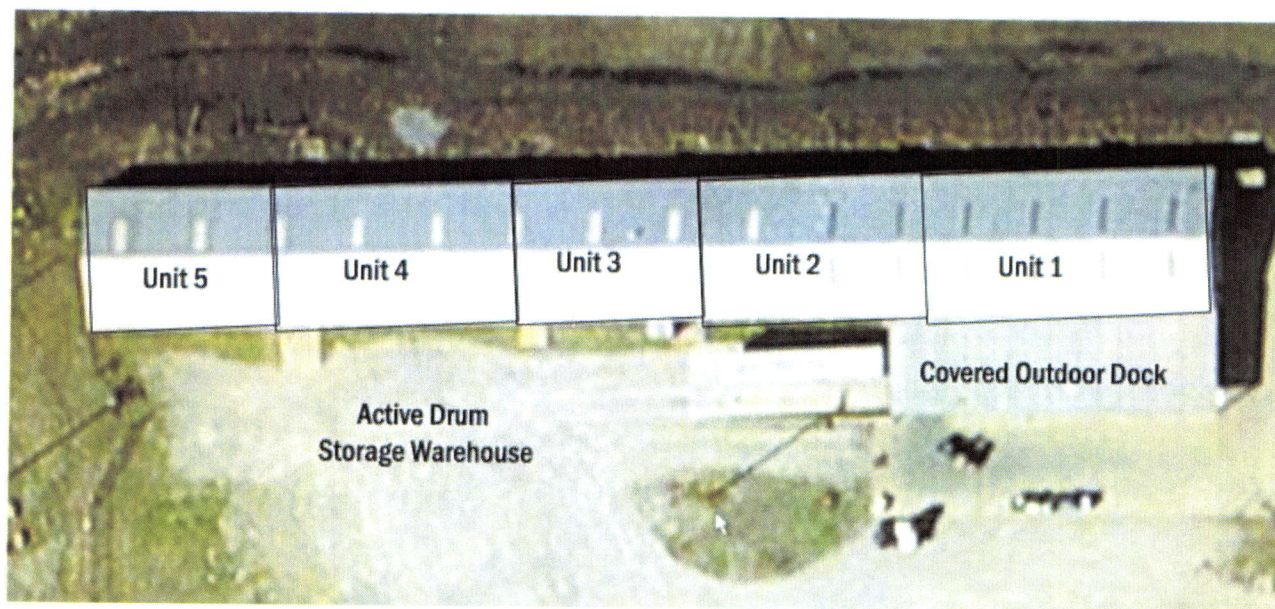
Figure 14. Building E – The current active drum storage warehouse.

The drum storage building is located in the West portion of the property and consists of a long warehouse with metal walls and roof and was also considered a class 2 area due to the nature of the activities being carried out in this building. This building was divided into five survey units consisting of 18-21, 8' x 8' sub-units each. As with all other buildings, this building was surveyed with 100% coverage for gamma exposure rate measurements. No measurements were found in excess of 11 mR/hr with the exception of measurements taken directly adjacent to drums containing waste activated charcoal filter media. Clean Harbors staff were asked to relocate the drums to allow for a survey of the floor in that area. Once the drums were moved, the gamma survey indicated only background gamma levels on the floor. No alpha/beta contamination was detected via direct counting and wipe sampling for this building.

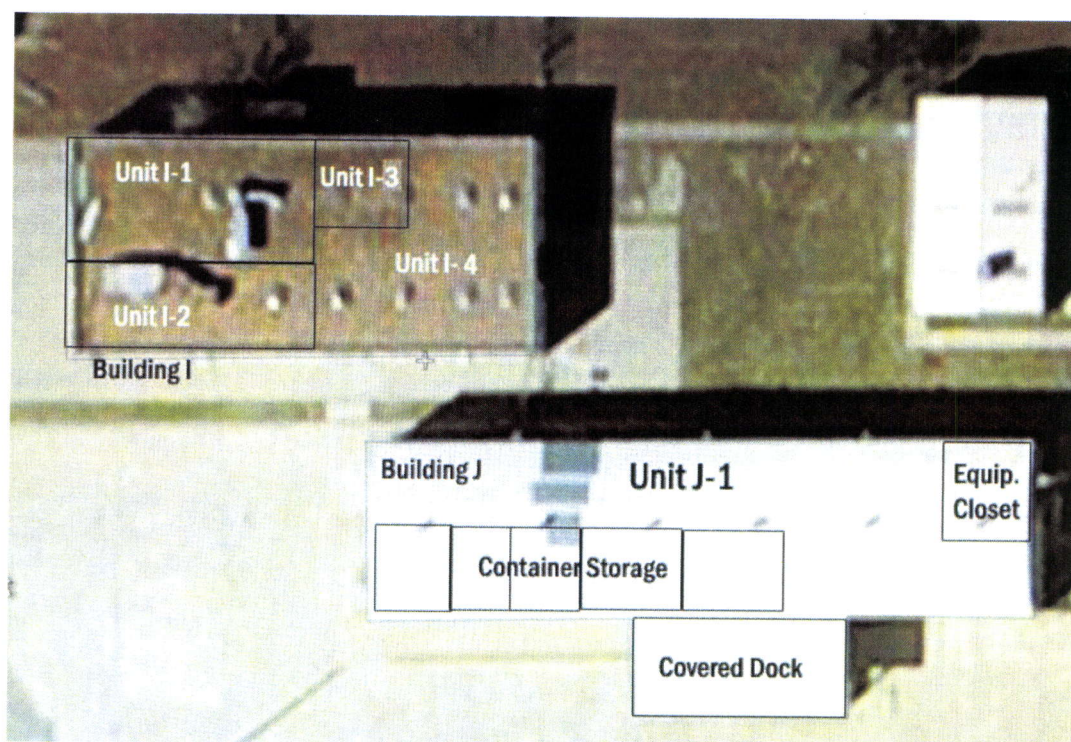
Figure 15. Buildings I and J survey unit layout.

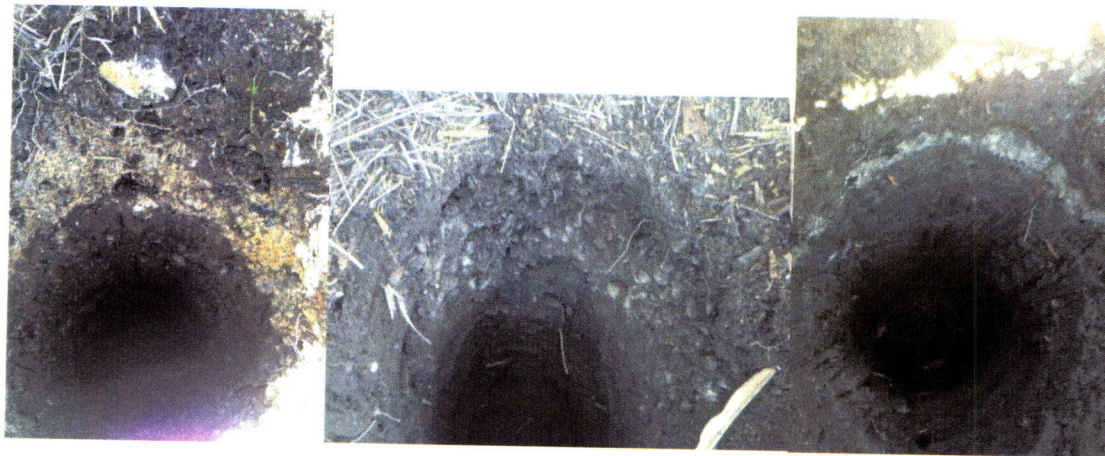
1D: Loose soil down to 4" followed by gravel layer ~ 4-6" deep, with uniform black clay/soil throughout the entire remaining depth down to 20" where natural solid clay layer was encountered.

1G: Loose soil for top 8" followed by bull-rock/sand layer for next 4". Dark black soil for next 2" followed by clay/soil mix for additional 6". Solid clay layer encountered at 20".

1J: Loose soil for top 2-3" followed by 2" crush rock layer followed by loose soil/clay for 8-10". Solid clay layer encountered at ~16" depth.

Figure 16. Soil sampling holes showing various strata. Sampling locations are 1G, 1D, 1J (from left to right).

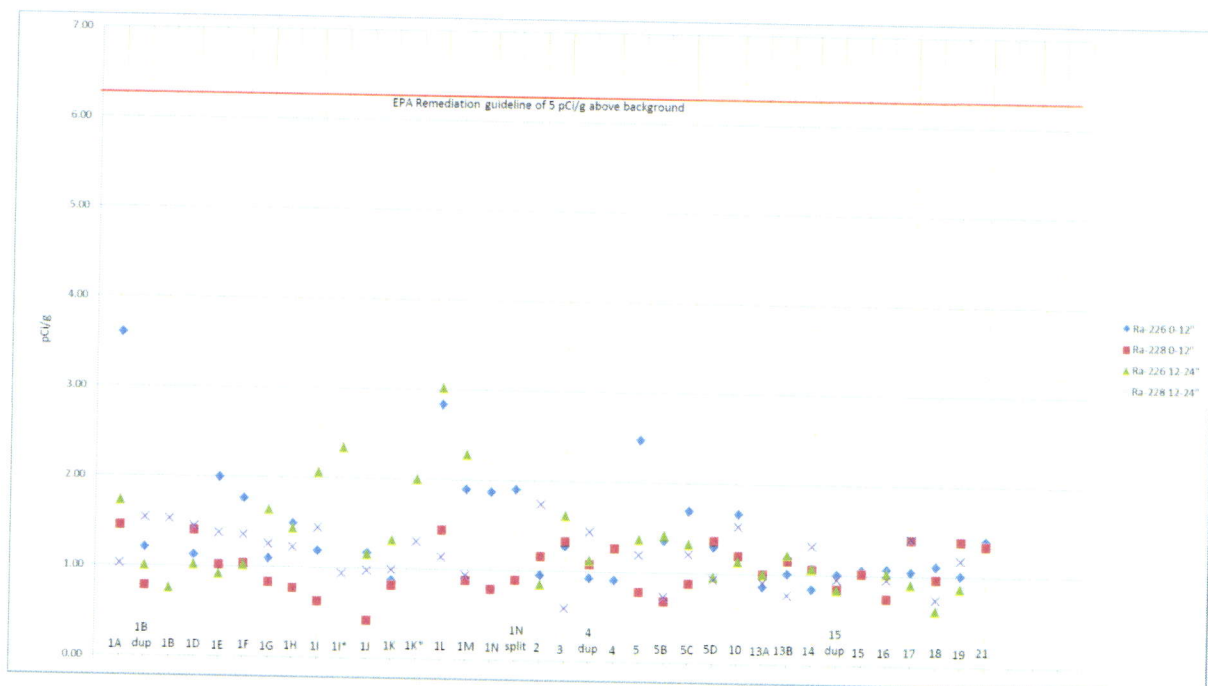
Figure 17. Graphical representation of sampling data relative to EPA guidelines. Although some results are distinguishable above background variance, maximum values are well below EPA criteria.

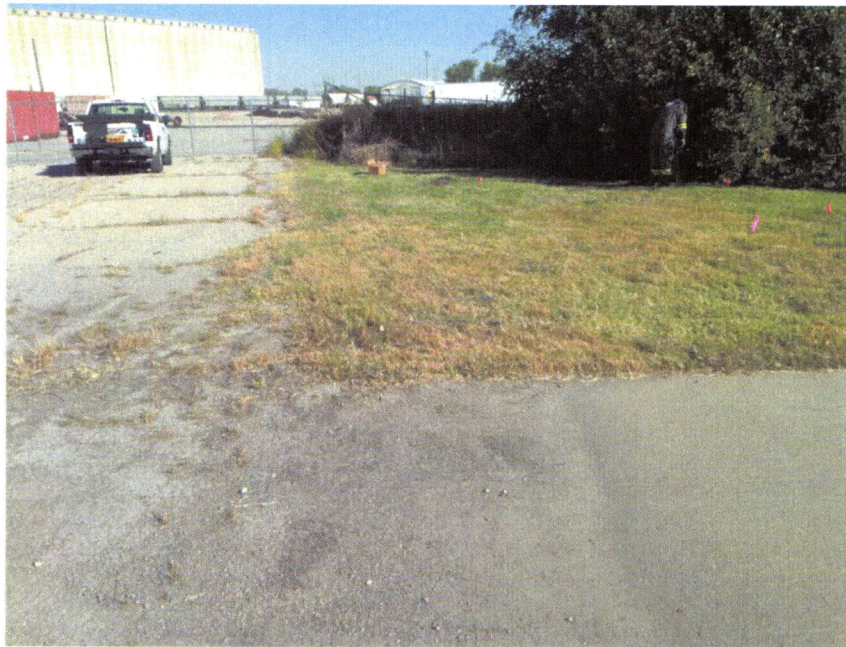
The only locations where the slightly elevated gamma measurements and initial soil sampling results for radium concentrations indicated potential contamination from past processes were in the Northeastern portion of the site (Unit 1), and a single discrete location in front of the drum storage warehouse (Unit 5). The area in Unit 1 was associated with hazardous drum storage and handling as well as a drain assembly that has been removed and back-filled at some point in the past. Unit 5 is adjacent to the currently ongoing drum management operations. Final sampling locations were chosen in order to bound the locations of elevated concentrations and to better determine average soil concentrations in these areas.

Figure 18. The investigation area in Unit 1: a small grass covered area bound by the concrete drive of Building I to the South, the paved roadway leading to the adjacent property to the West, and the tree-line to the Northeast.

During sampling across the area in Unit 1, it was noted that a backfill layer consisting of gravel and/or 2"-4' bullrock, and stabilizing sand was visible in all sampling locations. This layer varied in depth and thickness and was generally followed by a layer of loose soil and clay mix before reaching the solid clay layer. This material was initially suspected of containing radium contamination. However, based on the descriptions of the strata and the depth profile of the activity concentrations, it is more likely that the activity is contained in the loose soil directly beneath the gravel layer. All locations terminated in a solid clay layer which was assumed to be native clay and was verified as such by a drill crew performing operations on site at significantly deeper depths. All material encountered during sampling activities that was associated with historic excavation and backfill operations was located above the native clay layer.

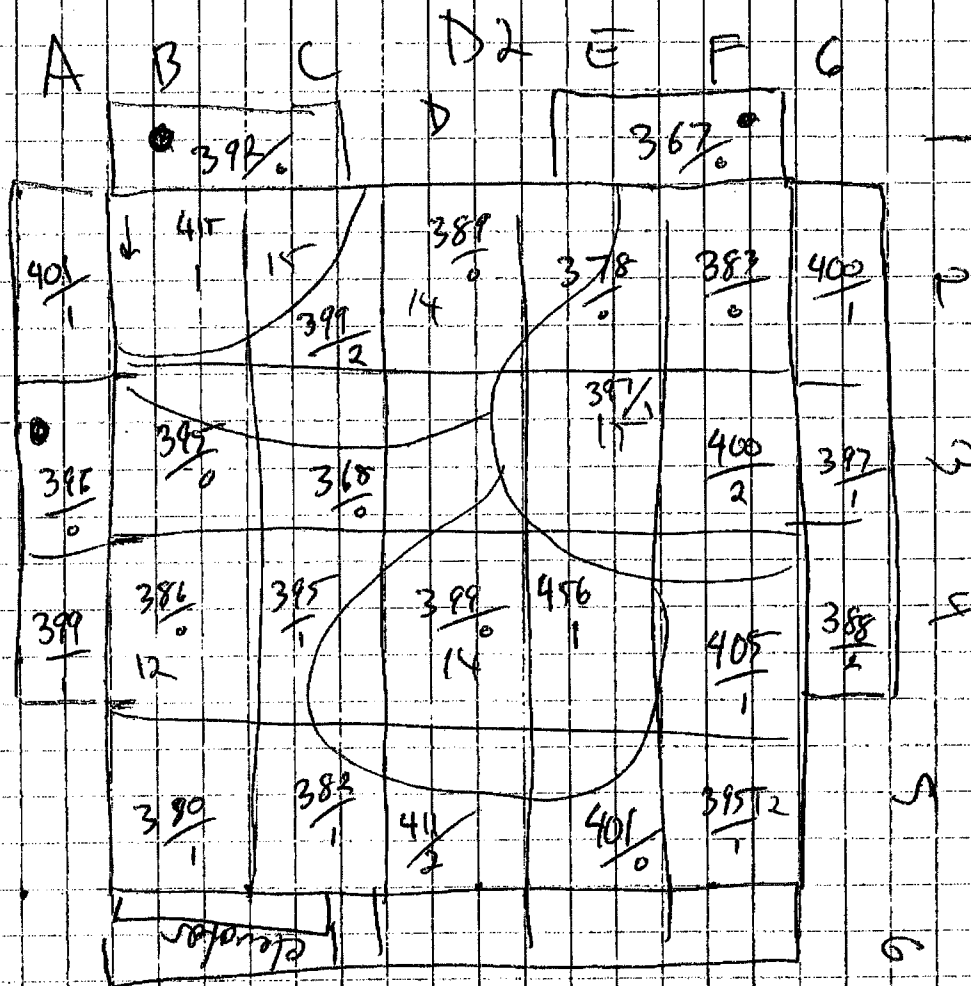
D-1

- 15 $\mu R/hr$ upper right corner along wall
in left corner
- 14 $\mu R/hr$ is crossway
- all others $< 12 \mu R/hr$
